Engineering Assessment of Two Cylinders Observed at the Douma Incident**- Executive Summary**

DRAFT FOR INTERNAL REVIEW
Expanded Rev 1 - 27 February 2019

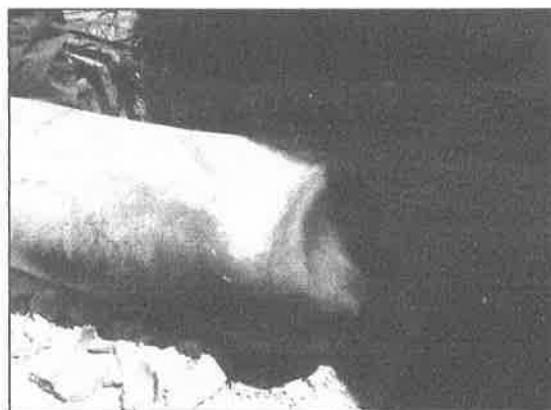
10. The key observations at Location 2 were the cylinder, which showed a specific mode and extent of deformation, and the crater. Critical elements of this study were identified as (1) cylinder deformation, (2) the size, shape and characteristics of the crater, and (3) a relative comparison of the cylinder and crater, i.e. was there the match of an assumed impact between the two?

23. The possibility of the observed deformation of the cylinder being the result of an intermediate impact with (for example) the corner of the terrace wall, was not consistent with the almost complete lack of deformation on the rest of the cylinder, nor was it consistent with the subsequent impact that would have led to the creation of the crater (as mentioned in paragraph 20). Similarly, the influence of the possible presence of wire netting above the terrace was calculated by using the yield stress for mild steel together with estimated wire thickness. The potential "cushioning" effect was found to be negligible when compared with the energy of a cylinder falling from the lowest estimated height.

24. Regarding the possible effect of the wire netting, a "criss-cross" pattern was observed on the paintwork of the cylinder body, which was attributed by some observers as an indication of the cylinder falling through the wire mesh. This explanation however is inconsistent with the vertical, or near-vertical, angle of incidence of the cylinder that was assumed (and would have been required) to have created the crater in the concrete slab.

Figure 3: Observed cylinder at Location 2

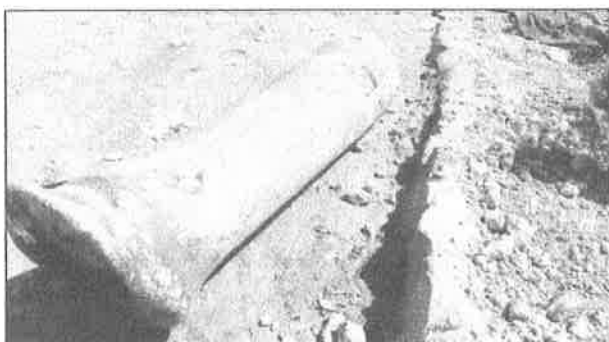
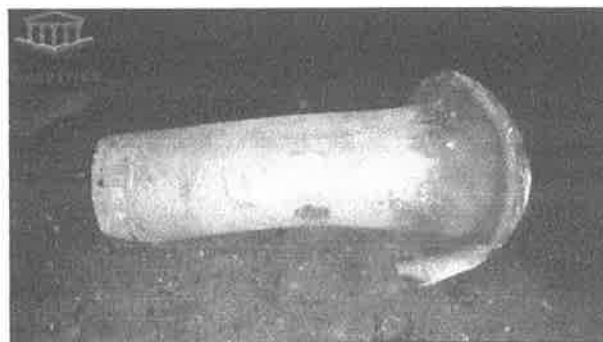
22. As mentioned above, the predicted cylinder deformation was not consistent with that observed on the cylinder observed at the scene at Location 2. The results predicted from the simulation were more consistent with images of deformed cylinders from earlier incidents of cylinders allegedly delivered from helicopters in the Syrian Arab Republic.

Figures 4 and 5: Cylinders from previous alleged incidents

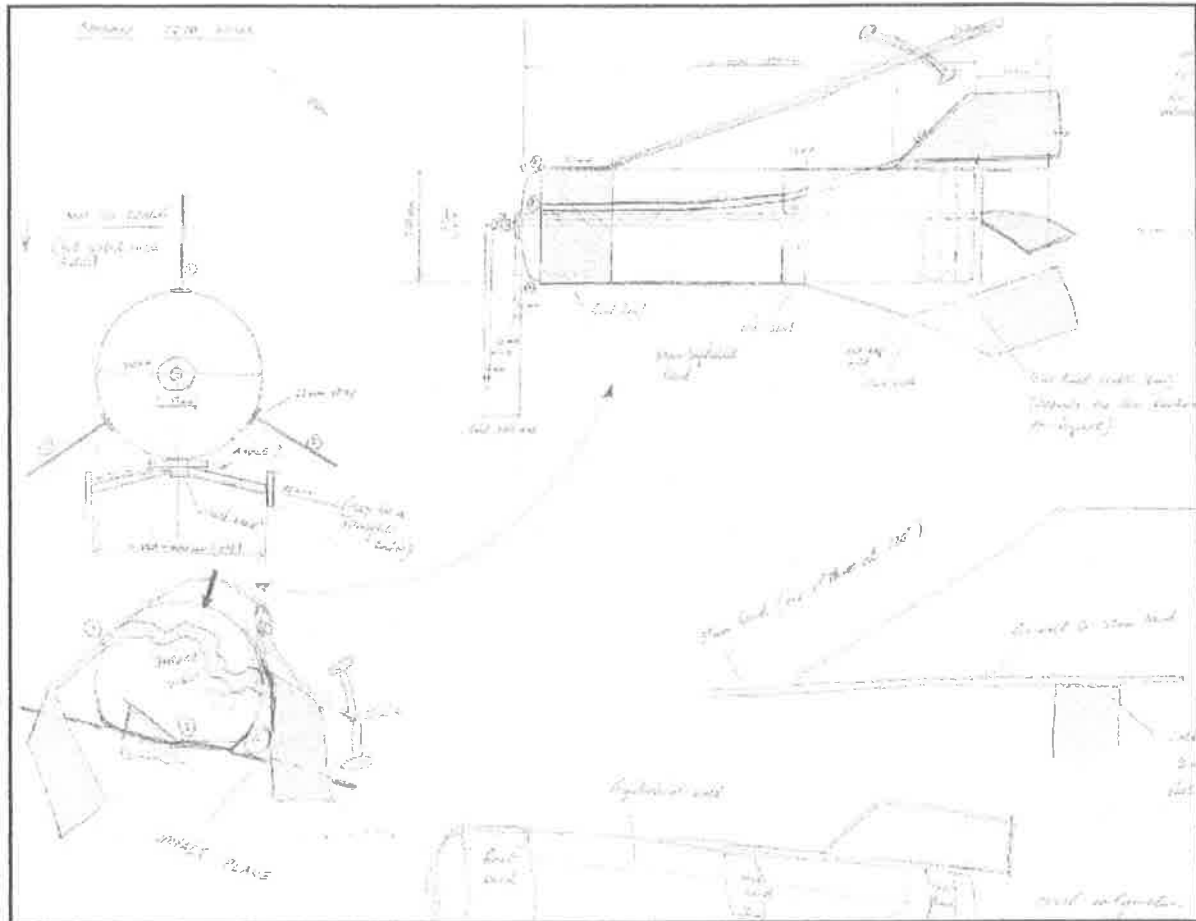
- Measurements, observations and photographs were taken inside the room; of the crater in the roof, the cylinder, walls, and objects of furniture and fittings within the room. These were used to establish a scale drawing of the deformed cylinder, to reconstruct pre-deformation cylinder dimensions, with un-deformed frame and fins, and to create a scale drawings of these taking into account that (in addition to deformation) the framework appeared to have been displaced backwards as a result of an impact.

Figure 7: Location 4 cylinder dimensions post-impact

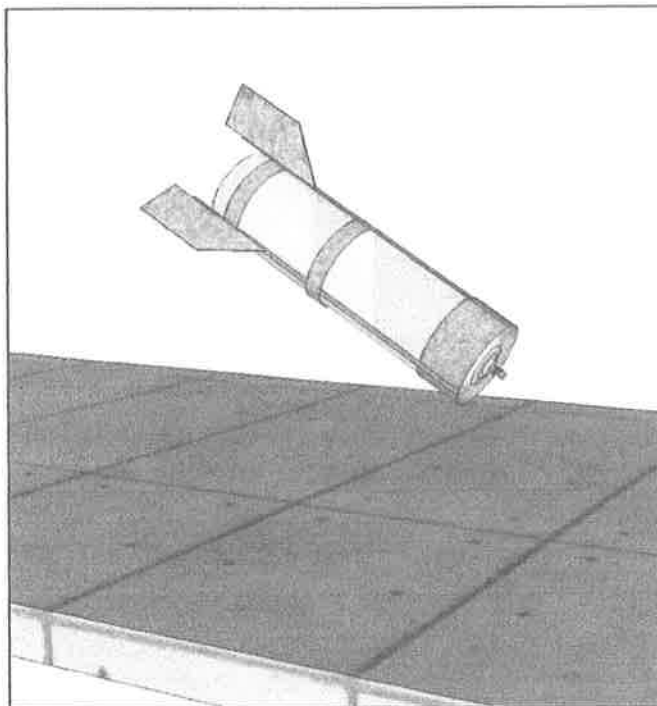
Figure 11: Test case - nose-down angle of incidence

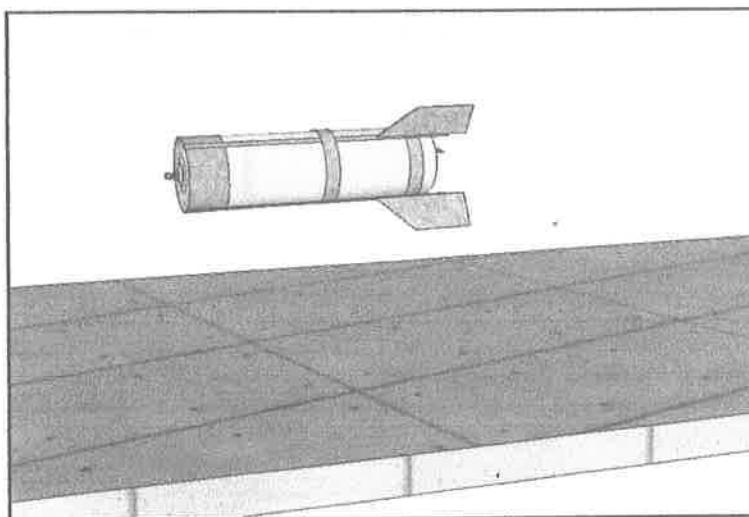
Figure 12: Test case - horizontal angle of incidence
